Why does the GV-UBL Camera show a white circular image during night surveillance?

Article ID: GV3-14-01-08-m

GV-UBL Series

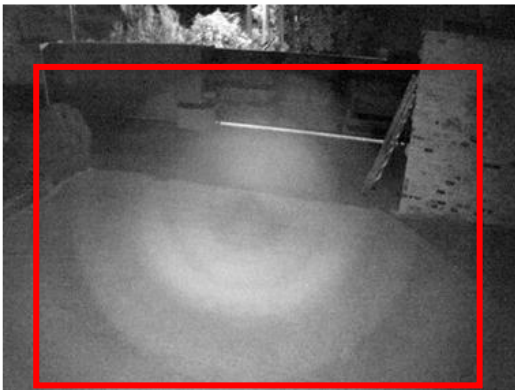
Why does the GV-UBL Camera show a white circular image during night surveillance?

A white circular image appears during night surveillance when the sun-shield cover of the GV-UBL Camera is installed incorrectly. Since the Infrared Light (IR) is turned on at night, the image is the result of IR reflection on the camera lens at night.

For proper installation of the sun-shield cover, look for the placement of the Geovision logo on it. The device is properly installed if the GeoVision logo is located near the camera lens on the sun-shield cover. The device is not installed correctly if the GeoVision logo is located furthest near the back of the sun-shield cover.

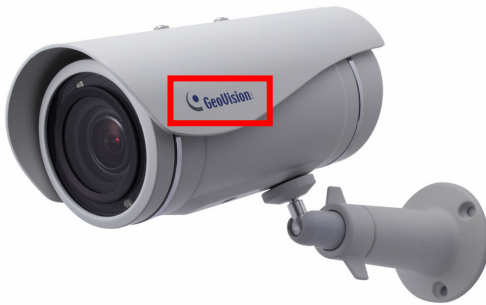
Correct installation

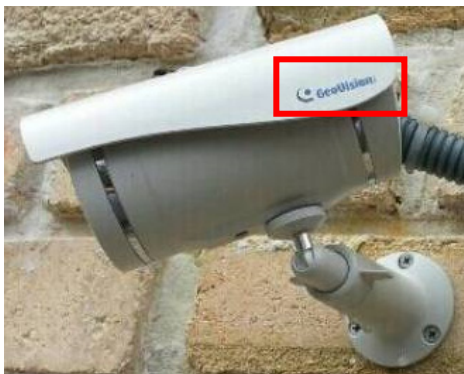
Incorrect installation
